EVALUATION OF DAMPNES IN RESIDENTIAL BUILDING IN KAURA-NAMODA ZAMFARA STATE, NIGERIA

The study was conducted in Kaura Namoda town, Zamfara State which is located in the Northwestern geopolitical zone of Nigeria. It was founded in 1807 and has an area of 868 km² and a population of 281,367 at the 2006 census. The building used as a case study is a flat house of three bedroom, located in the Sabuwar Kaura area with coordinates of 12⁰35'11"N; 6⁰ 35'21"E. It was remodeled in year 2017

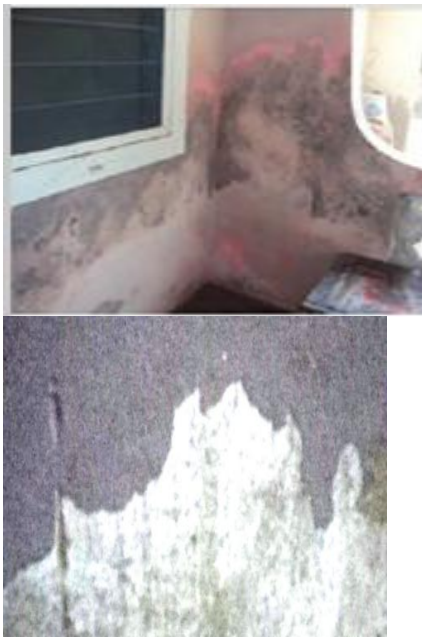
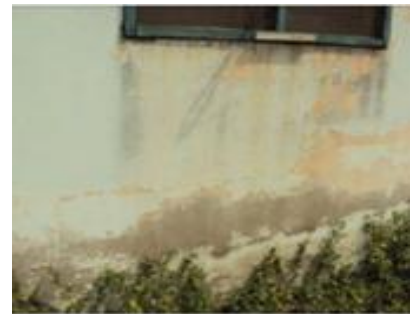
a) Stain in the horizontal band; b) Water run marks on windows; c) flaking of paint
Figure 1: Affected areas of building identified during visual inspection

The investigation revealed that there were combinations of several sources of dampness. These included plumbing leakages, rising dampness, condensation, among others. This stage further revealed that dampness in the walls of the building was associated with symptoms such as

blistering of paint, flaking of plaster, surface efflorescence and stains on the walls. Symptoms such as surface efflorescence, damp base of walls up to 1.5m in horizontal band, among others, closely related to rising dampness were identified.
